Failure analysis of blades and vanes of a compressor for a gas turbine engine

Hyeok-Jun Kwon, Dooyoul Lee, Young-Kook Lee

**Keywords:** Engine failure; Compressor stator vane failure; Fatigue failure; Coarse grain; IN 718

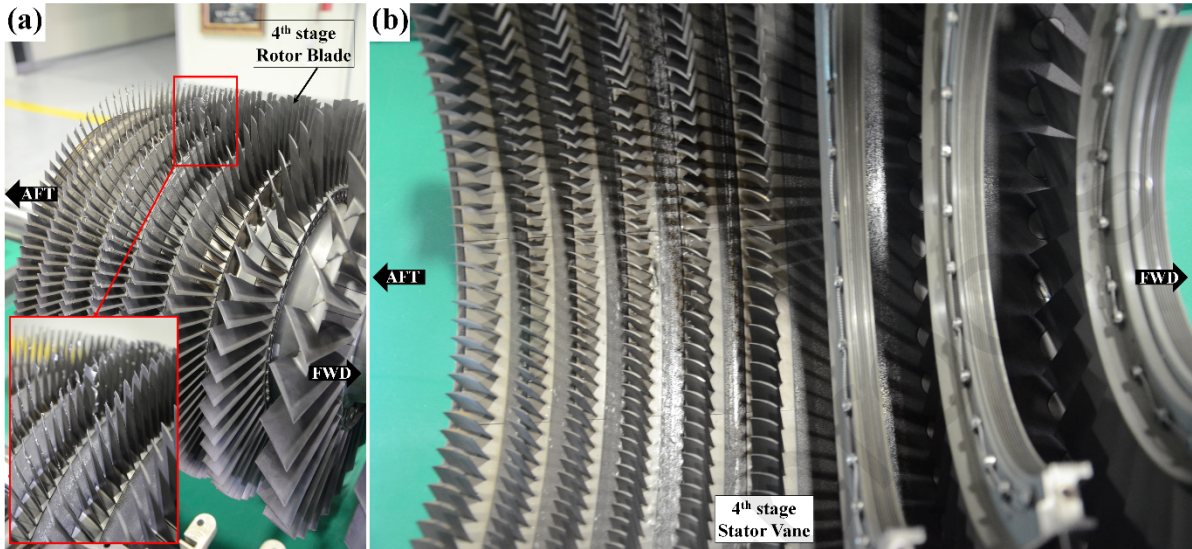
The engine failure occurred during take-off run. When the compressor was disassembled, it was readily found that rotor blades at stages V-VIII were damaged (Fig. 1a). However, the damage of stator vanes was difficult to be observed until the stator vane assembly in Fig. 1b was disassembled. Finally, severe damages were found from stage IV (Figs. 2a and c) after the dismantlement of the stator vane assembly. In particular, a vane at stage IV and a vane at stage V, five blades at the stage V and a blade at the stage VI were fractured. Regarding the stage IV, the trailing edge (TE) region of a vane was fractured with a size of  $\sim 5\text{ mm} \times \sim 32\text{ mm}$  (Fig. 2a), and the other vanes had only nick damages. The blades at stages V and VI were fractured at different positions (Fig. 2b). Moreover, nick damages were observed in leading edge (LE) and TE regions. As seen in Fig. 2c, the vane of the stage V was fractured at the position of 13 mm away from the outer-platform part, and damages were observed in the TE region. Damages were also observed in the TE region of the other vanes of the stage V.

Fig. 1. Damaged compressor part of (a) rotor blade assembly and (b) stator vane assembly.

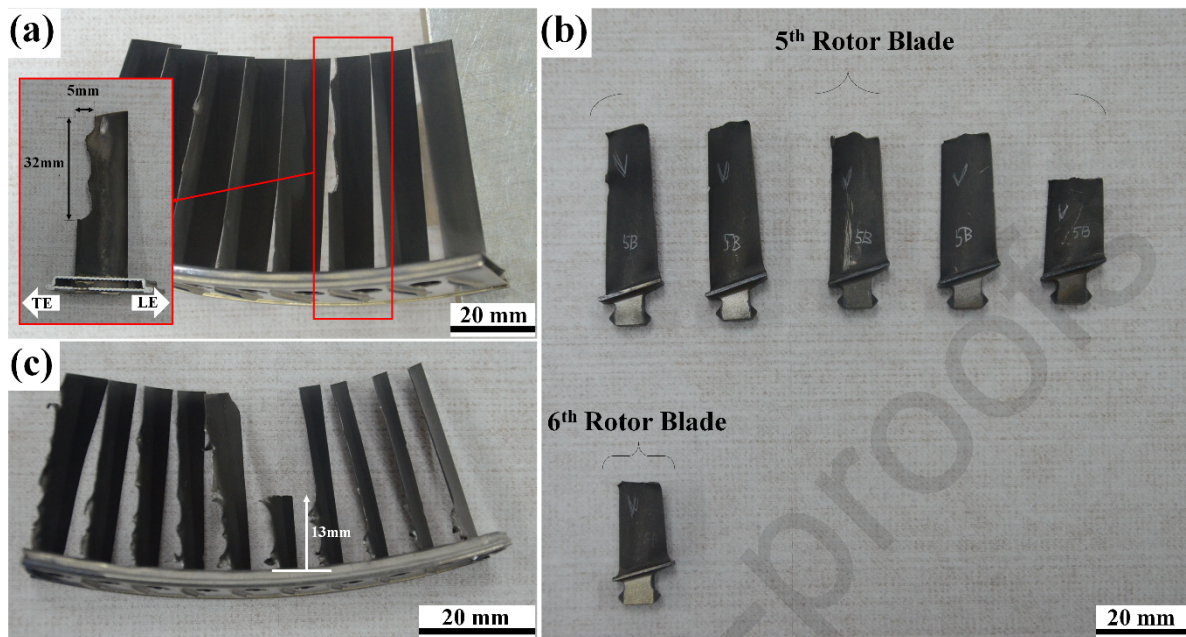
The fractography of the fractured vane at the stage IV was performed (Fig. 2a). Severe oxidation and abrasion were observed throughout the fracture surface (Fig. 3a). No information was obtained due to abrasion at the tip (Fig. 3b). At a location 6 mm away from the tip, fatigue cracks started from each side of concave and convex parts (Fig. 3c); fatigue striations (yellow arrows in Fig. 3c) were observed at some fractured surfaces. Moreover, overload fractured surfaces were observed at the last stage of general fatigue cracking and the fractured surface exhibited a dimple structure (Fig. 3d). This observation indicates that cracking started from the tip and grew diagonally to the outer-platform and TE.

Fig. 2. Fractured and damaged components of (a) Stator vanes of stage **IV**, (b) rotor blades of stages **V** and **VI**, and (c) stator vanes of stage **V**.

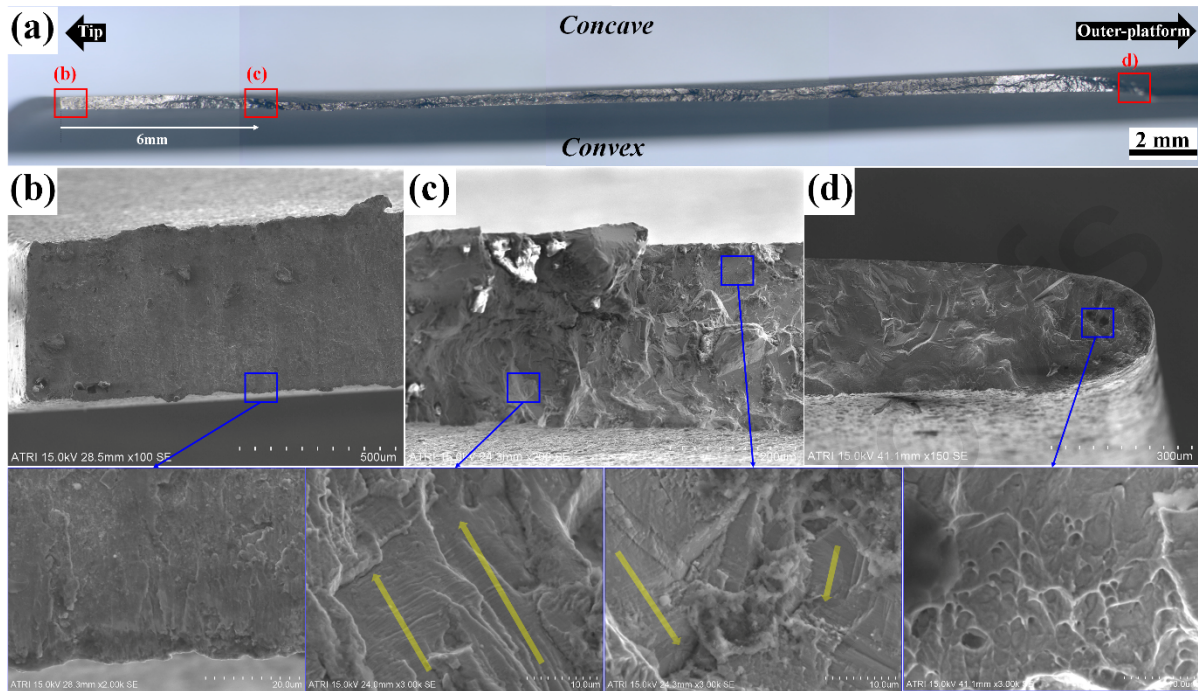
Based on the results mentioned above, it was realized that the flame-out of the gas turbine engine stemmed mainly from internal object damage (I.O.D) caused by the fracture of the stator vane of stage **IV**. However, since the initiation point of fatigue cracking was completely contaminated by wear and oxidation, it was difficult to elucidate the root cause of fracture. Nevertheless, based on failure cases [7-9, 19-21], it can be deduced that the compressor vane of the gas turbine engine might be fractured by corrosion. Corrosion is a typical cause of damage occurring at various parts of aircraft, and can serve as a starting point for fatigue cracking. In the present study, micro-corrosion (i.e., pitting) was also observed at the tip of the vane of stage **IV** (Fig. 6). Another cause of fracture is dispersion of material strength. Even if all materials undergo heat treatment and manufacture process under complete control, the inhomogeneity of material properties may exist. Furthermore, mechanical properties may also change depending on the environment that the material is exposed to [22].

- a. The cause of fatigue cracking in the stator vane of stage **IV** was not confirmed due to the severe contamination of the crack origin. However, corrosion is considered to be the cause of cracking due to the presence of corrosion pits observed on the surface of airfoil.
- b. The rotor blades of stages **V** and **VI** were failed by fatigue cracking that was initiated at the damaged part. The chemical elements of the vane were detected at the damaged part of rotor blades. This implies that the damages of rotor blades were caused by the fragments of the vane.
- c. The stator vane of stage **V** was failed by fatigue cracking, which was initiated at the middle part of the convex surface, not the nick damage part. Compared with the sound

Fig. 3. (a) OM image of the entire fractured surface of a stator vane of stage **IV**. Magnified SEM images of (b) tip, (c) middle and (d) outer-platform parts corresponding to red boxes in (a). Yellow arrows indicate fatigue striations.

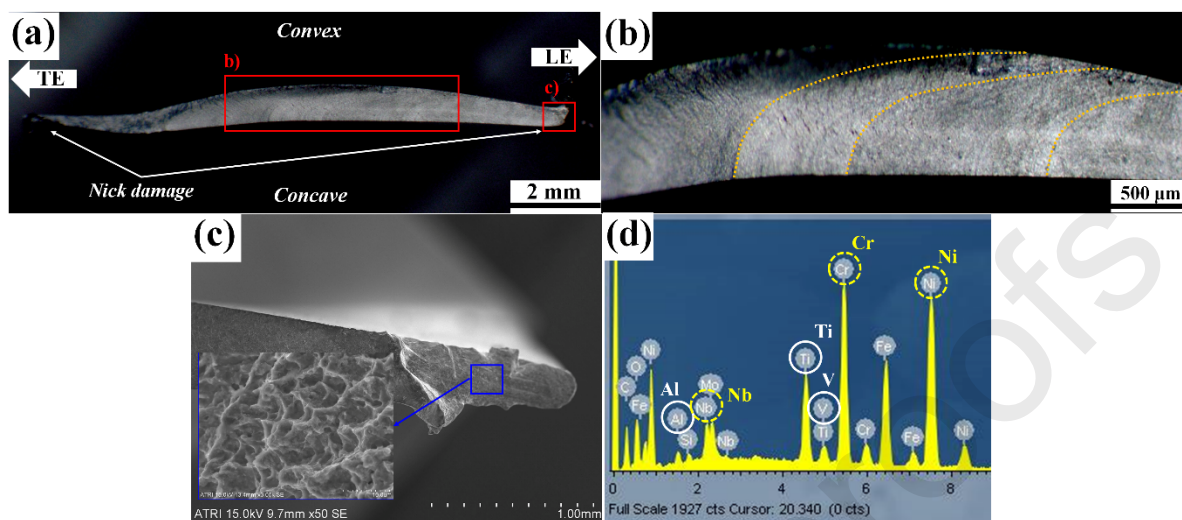
Regarding the rotor blade at the stage V, nick damages were observed in LE and TE regions (Fig. 4a). Clear fatigue striations were not observed on the fractured surface at the SEM images. However, a beach mark which formed from LE towards TE, was observed at the OM images (Fig. 4b). This is indicative of the occurrence of fatigue cracking. The damaged part of the LE region exhibited a dimple structure, i.e., a trace of overload fracture (Fig. 4c). In addition, the SEM-EDXS result (Fig. 4d) shows that the LE region of the blade possesses the same chemical elements (Ni, Cr and Nb) with main chemical elements of the vane. This indicates that the initial damage in LE was caused by vane fragment. That result was observed in five blades of stage V and a blade of stage VI.

Regarding the blades of stages **V** and **VI**, the damages of LE and TE were confirmed, and the fatigue crack was propagated from the damaged part of LE (Fig. 4). The SEM-EDXS result exhibited that the LE parts of blades were damaged by broken fragments of vanes. Accordingly, it is considered that the damaged LE parts provided stress concentration sites and the origin of fatigue cracking. Fatigue cracks, caused by stress concentration at the damaged part, are frequently reported in many previous studies [5, 23].

Fig. 4. Fractured surface of a rotor blade of stage **V**: OM images of (a) the entire fractured surface and (b) the middle part corresponding to red boxes in (a). Dotted yellow lines in (b) indicate the beach mark. (c) SEM image of the surface fractured by nick damage, and EDXS patterns of (d) nick-damaged area (LE side).

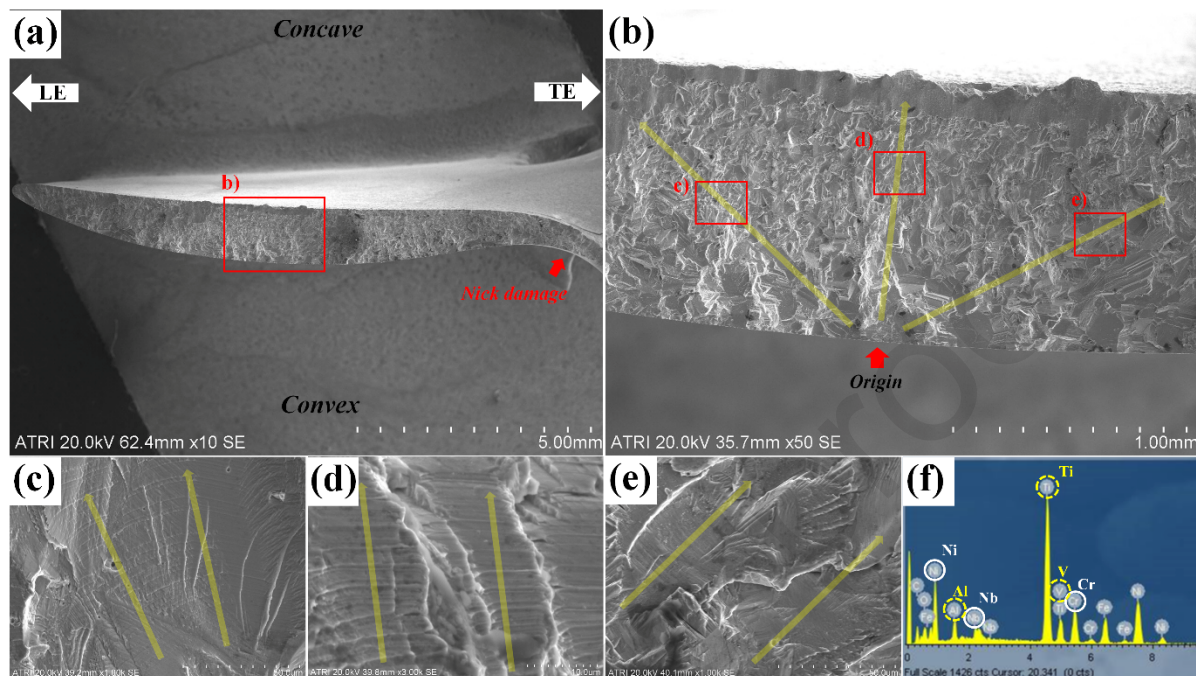
part of airfoil was fractured and nick damages were observed only at the trailing edge (Fig. 2c). The Fig. 5 shows the fractured surface of the failed vane of the stage **V**. As shown in Fig. 5b, the fatigue crack was initiated and propagated from the center of the convex surface, not from the damaged part of TE (Red arrow in the fig. 5a). The direction of fatigue cracking was determined by the formation of fatigue striations (Figs. 5c-e). The main chemical elements of the blade, such as Ti, Al and V, were detected at the damaged part of the vane (Fig. 5f).

of stage **V**. However, even if the vane of stage **IV** did not break, the possibility of engine damage is thought to be high because the vane of stage **V** had fatigue cracks (Fig. 5). The reason is that the initiation site of fatigue cracking was not the location where nick damage was observed. The cause of the fatigue crack is considered to be due to coarse grains present in the convex surface (Figs. 8 and 9). Abikchi *et al.* [24] reported that fatigue cracking started primarily from coarse grains in Inconel 718 and experimentally showed that Inconel 718 with coarse grains possessed the lower cycle for the start of fatigue cracking. The possibility of fatigue cracking increases due to the low fraction of  $\Gamma''$  precipitates within coarse grains and irregular distribution of slip bands [25]. In addition, Inconel 718 is known to follow the Hall-Petch theory, where the strength increases with grain refinement [26]. In other words, fatigue properties deteriorated due to coarse grain formation on convex surface of the vane. Meanwhile, coarse grains on the surface form during heat treatment and manufacturing process [27, 28].

Fig. 5. (a) SEM image of a fractured stator vane of stage **V**. (b) Magnified SEM image of fractured surface corresponding to a red box in (a). (c-e) Magnified SEM images of fractured surface corresponding to red boxes in (b). Yellow arrows indicate the direction of fatigue crack propagation. (f) EDXS pattern of nick-damaged area on the fractured surface of the vane.

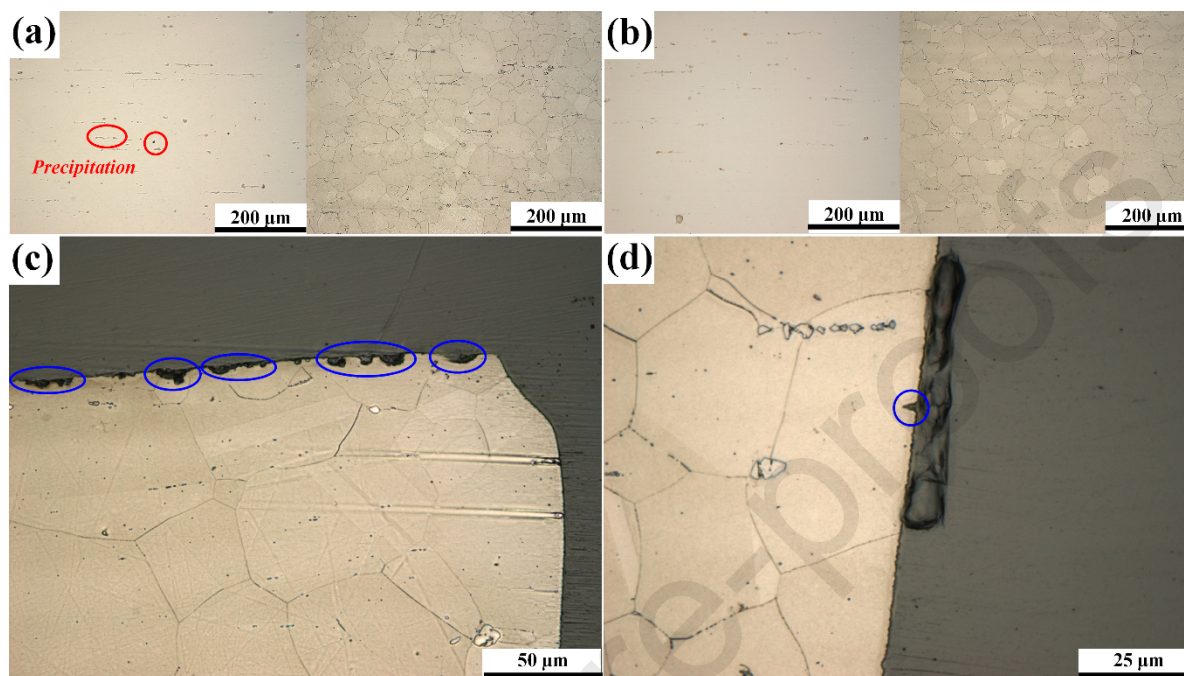
Except for the blades at stages **V** and **VI**, in which fatigue cracks caused by nick damages are clearly observed, microstructures of the vanes at stages **IV** and **V** were observed. Compared with the sound vane (i.e., unfractured vane) of stage **IV**, both fractured (Fig. 6a) and sound (Fig. 6b) vanes revealed no significant differences in grain size and precipitate fraction (Fig. 7), which could affect fatigue cracking. Meanwhile, some defects were observed at the surface of concave and tip near the fracture surface (blue circles in Figs. 6c and d). The cross-sectional shape of the surface defect is similar to a typical shape of a corrosion pit. The oxygen was detected near the defect by the SEM-EDXS analysis although the measured oxygen content (~8 wt.%) is less than the oxygen content (> 15 wt.%) measured from corrosion pits in literature [17, 18]. This is probably because the size of the defect observed in the present study was so small that the chemical composition of a matrix or a resin near the defect was measured together.

Fig. 6. OM images of (a) sound and (b) fractured stator vanes observed from a leading edge direction. (c, d) OM images showing the vicinity of the tip of the fractured vane.

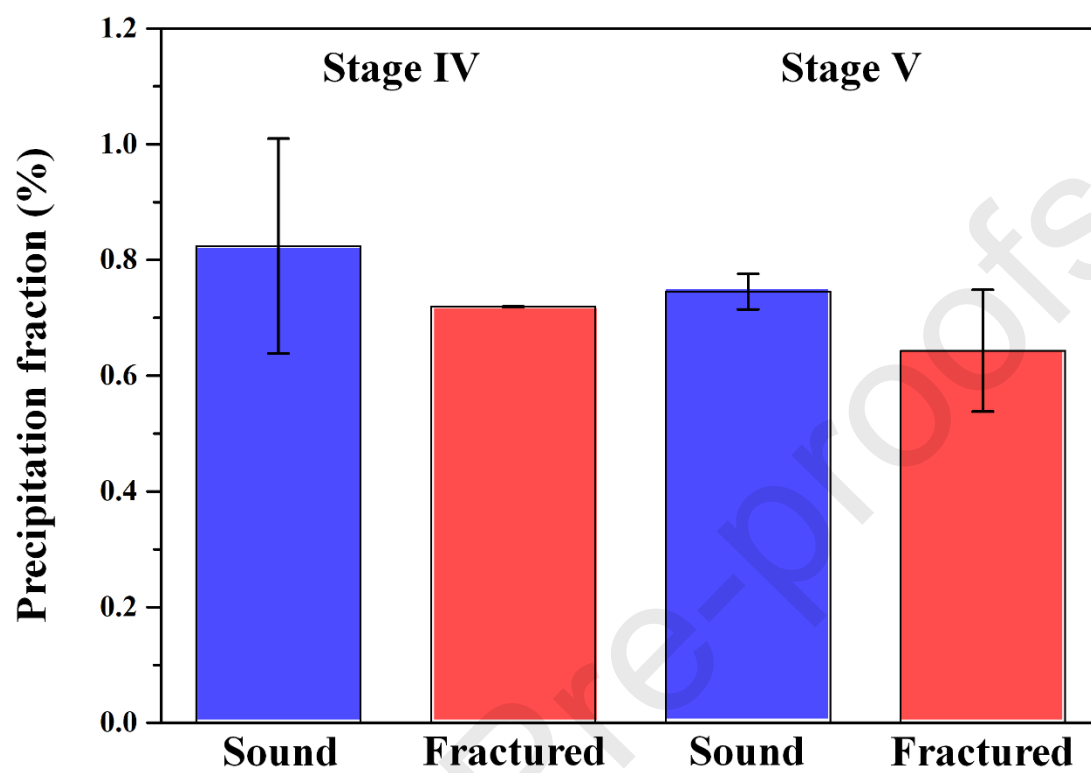
Fig. 8 exhibits microstructures of sound (Fig. 8a) and fractured (Fig. 8b) vanes of stage **V**. Both vanes revealed a similar fraction of precipitates (Fig. 7), but different grain sizes. In particular, the fractured vane possessed coarse grains in the convex surface. To evaluate the distribution of grain size, SEM-EBSD observation was performed (Fig. 9). As a result, the

Fig. 7. The fractions of precipitates measured at fractured and sound vanes in the stage **IV** and **V**.

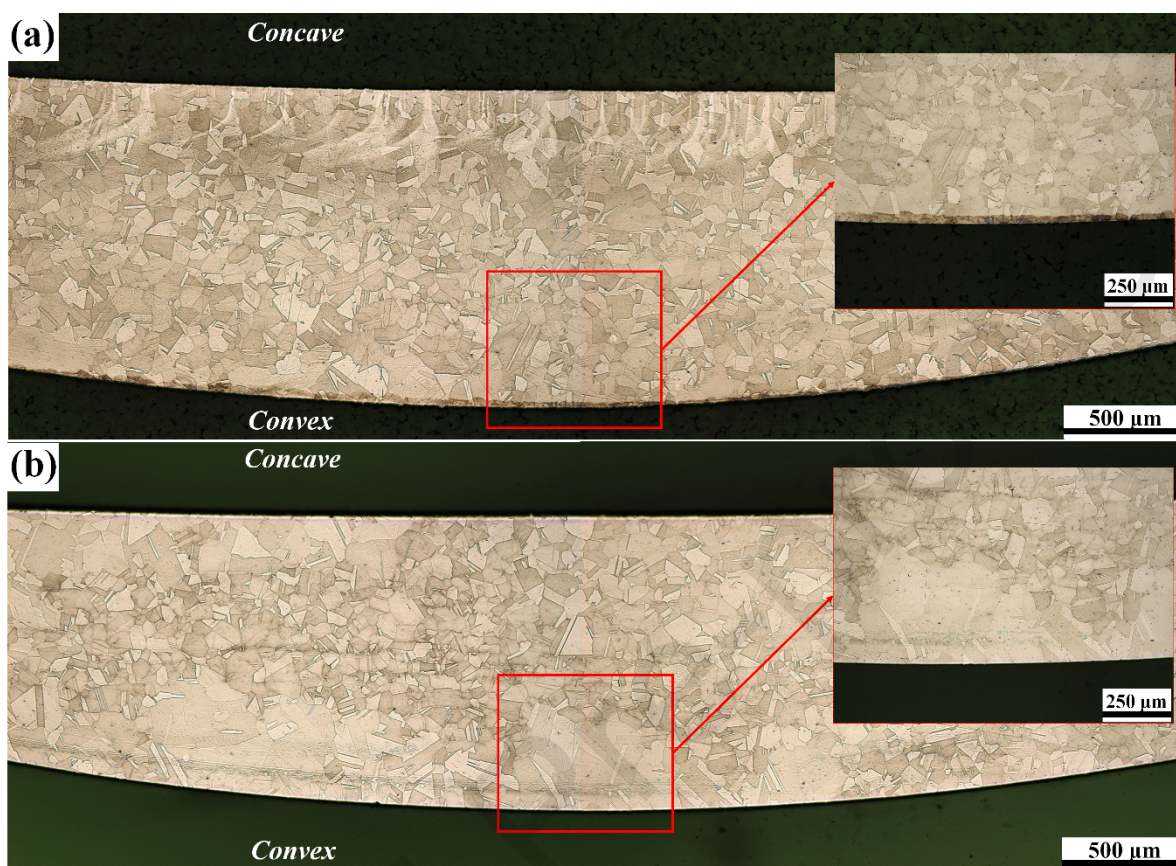
Fig. 8 OM images of (a) sound and (b) fractured stator vanes observed from the tip direction.

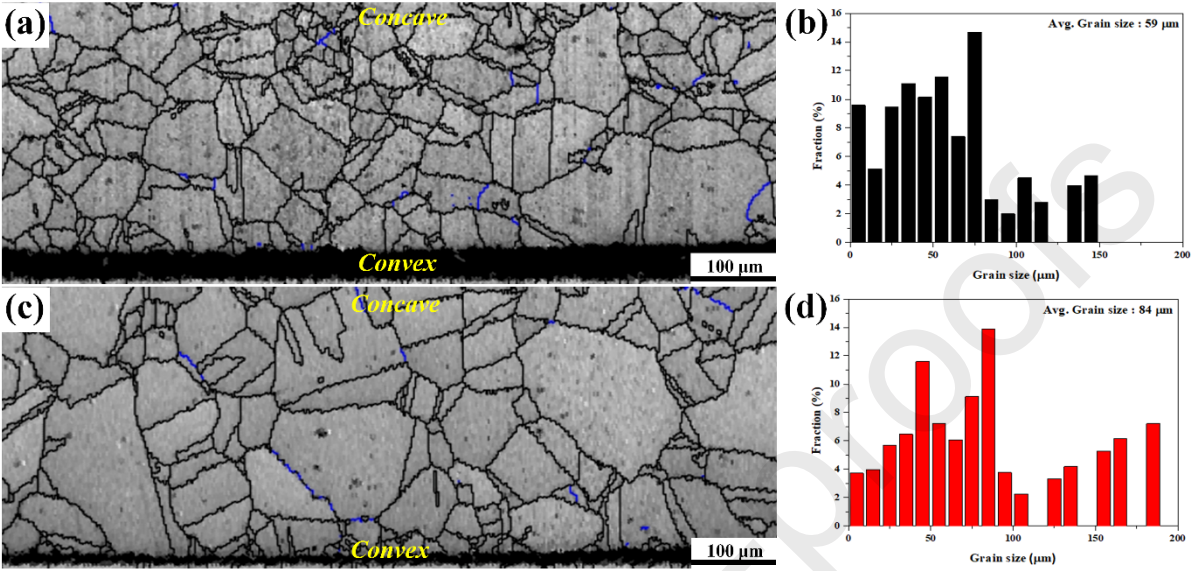
grain size of the sound vane (Figs. 9a and b) was finer than that of the fractured vane (Figs. 9c and d).

vane, the fractured vane possessed coarser grains at the convex surface. It is deduced that coarse grains are the main cause of fatigue cracking.

Fig. 9. (a, c) EBSD image quality (IQ) maps and (b, d) distribution of grain size: (a, b) sound and (c, d) fractured vanes. Blue lines are low-angle boundaries with misorientation angles of  $3^{\circ}$ - $15^{\circ}$ . Black lines are high-angle boundaries with misorientation angles exceeding  $15^{\circ}$ .
