CIV-E4040 Reinforced Concrete Structures

Examination 16.4.2020 (remote examination using My Course)

3. The figures below represents a test made for a high beam. (altogether 5p)
 - a) Identify the failure mechanisms that can be observed in the figures (2p)
 - b) Define a strut-and-ties model or models that could be used to study structural capacity for the failure mechanisms. (2p)
 - c) Justify the mechanism that led to the final failure. (1p)

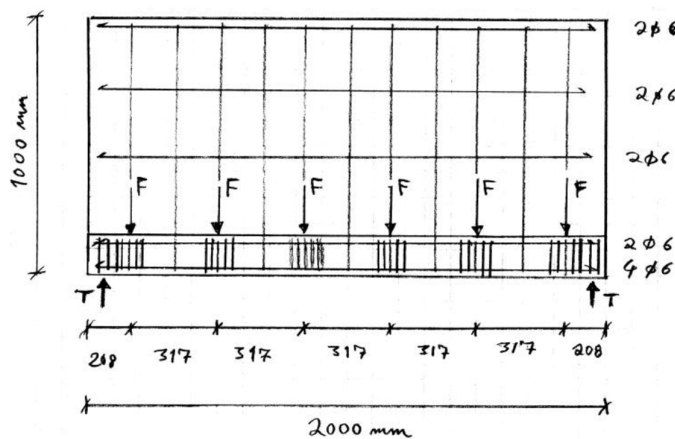
Geometry, reinforcement and loading of the beam

Stirrups differ from the drawing:
At loading points (F):
3Ø10
At supports (T)
3Ø6

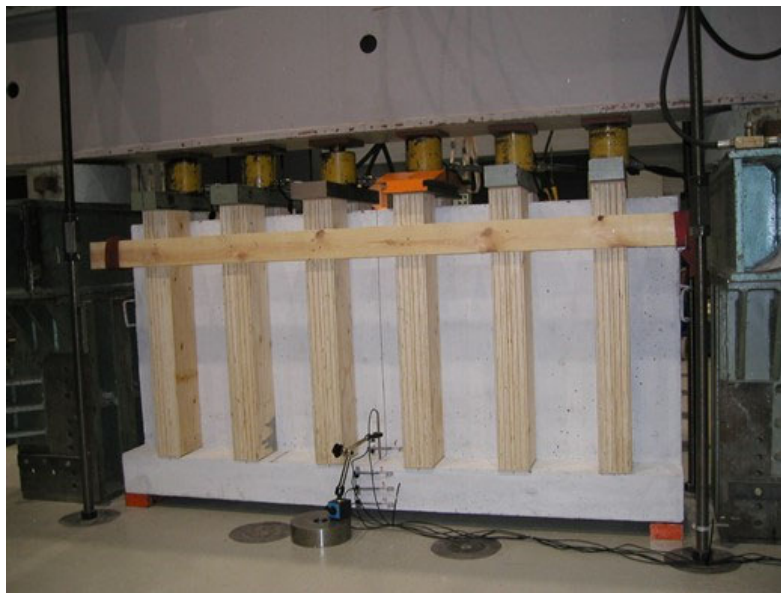
Test arrangement in the testing hall

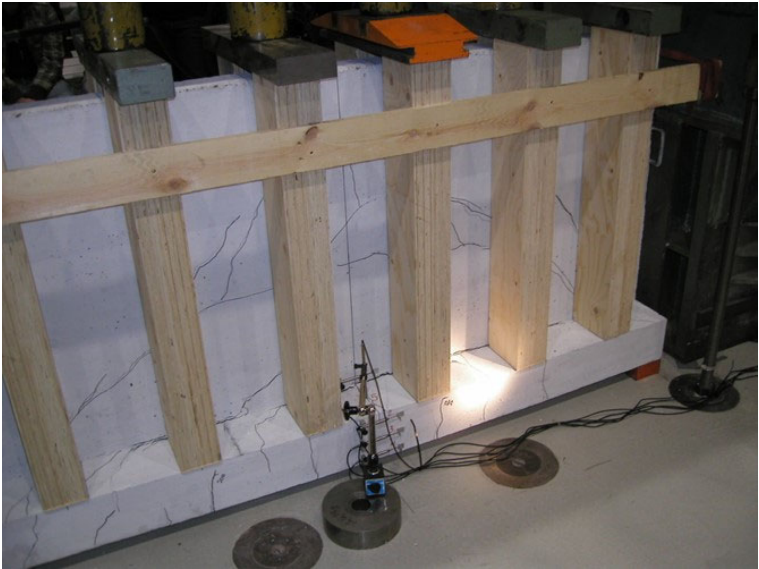
Developing of craking

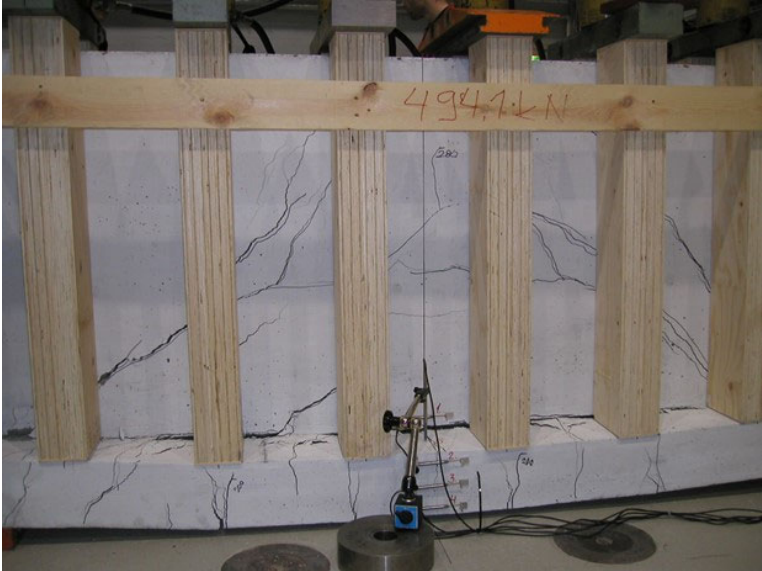
Cracking at the maximum load

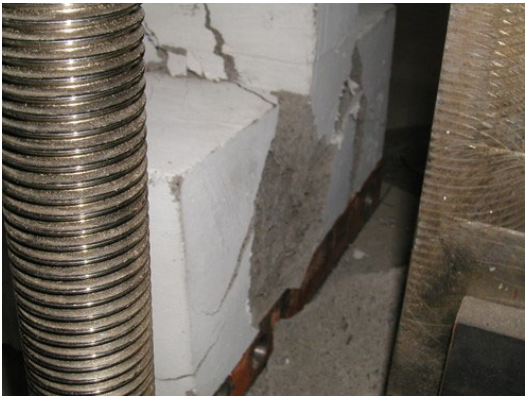
Cracking on the lower end of the beam
